***PHASE I ENVIRONMENTAL
ASSESSMENT OF THE
DOUGLAS AIRCRAFT COMPANY
C-6 FACILITY, PARKING LOT AND
TOOL STORAGE YARD
LOS ANGELES, CA***

**MCDONNELL DOUGLAS
REALTY COMPANY**

CAMP DRESSER & McKEE INC.
Irvine, California

June 13, 1991

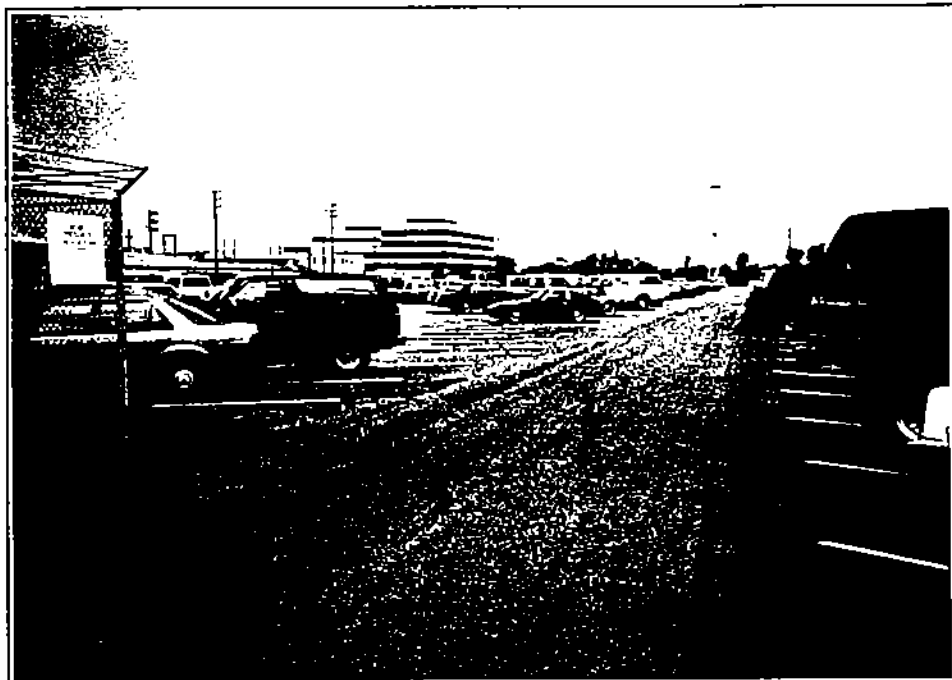
PHOTOGRAPH NO. 1

DESCRIPTION View of parking lot to the north. Note high voltage lighting tower in background.

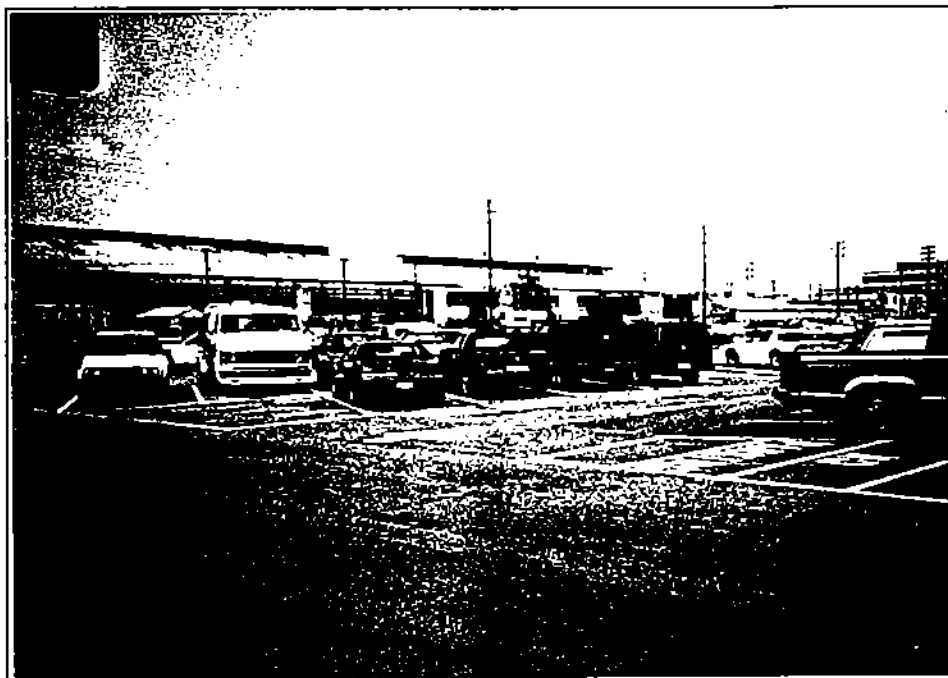
PHOTOGRAPH NO. 3

DESCRIPTION View of parking lot to the northwest with International Light Metals in the background.

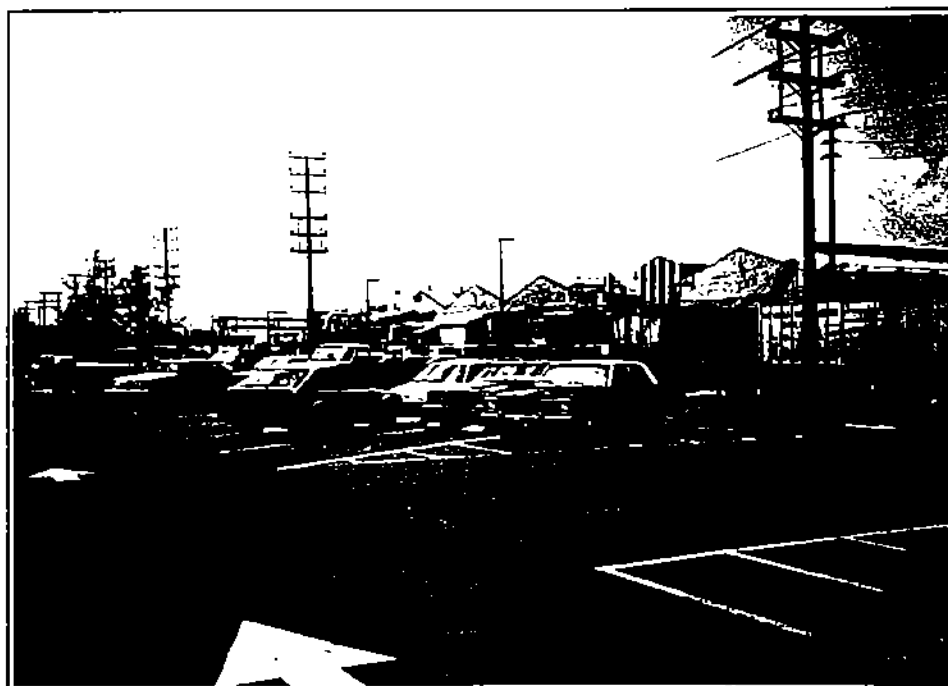
PHOTOGRAPH NO. 4

DESCRIPTION Southwest view of parking lot with International Light Metals in the background.

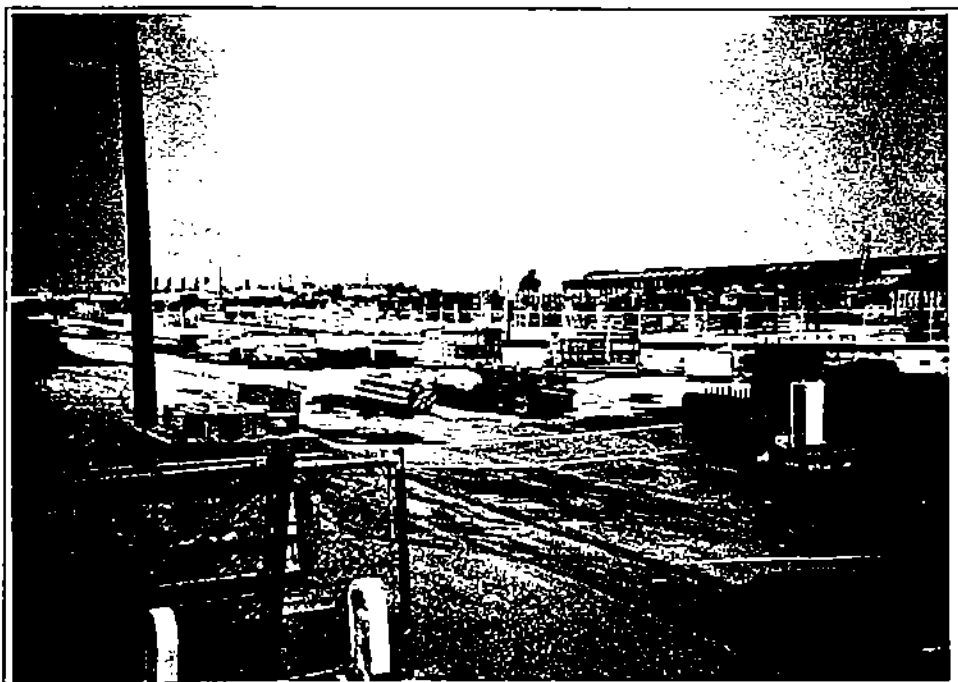
PHOTOGRAPH NO. 6

DESCRIPTION View of tool storage yard toward the west with Capital Metals in the background (right).
